Collision between the *Riley Elizabeth* Tow and
US Army Corps of Engineers Barge Plant
Mississippi River near Waterproof, Louisiana
July 18, 2014

Marine Accident Report

NTSB/MAR-15/03
PB2016-101374

Abstract: This report discusses the July 18, 2014, accident in which a downbound tow on the Mississippi River collided with a revetment project barge plant. No one was injured in the accident; however, the damage totaled about \$300,000.

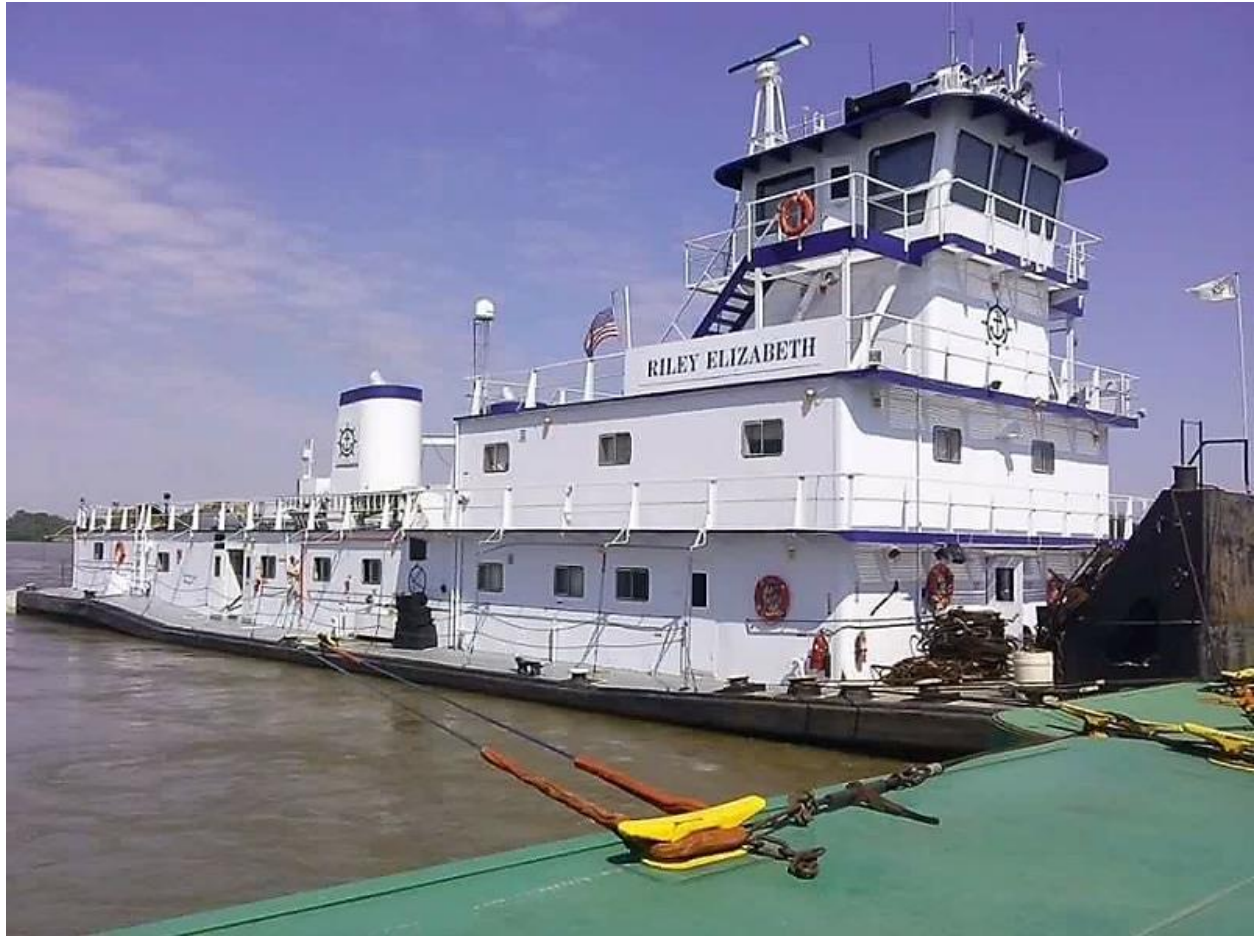
Figure 1. Postaccident photo of the *Riley Elizabeth* on the Mississippi River. (Photo by Western Rivers Boat Management)
